Profile

GateGourmet

Challenge *Metal Roof with Major Leaks*

Solution *AcryShield® Restoration System*

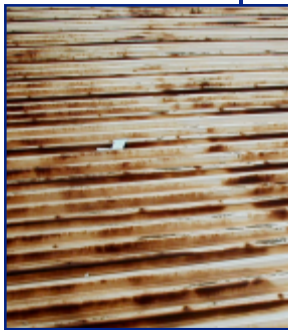
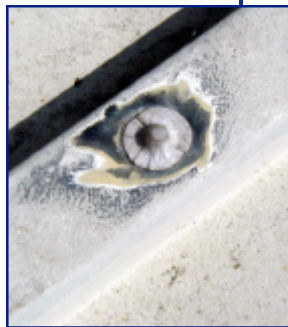
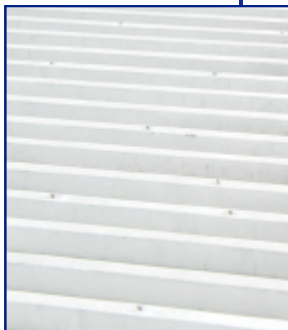
- Leaking metal roof.
- Localized corrosion.
- Deteriorated waterway paneling.

- Repair and replacement of severely deteriorated paneling.
- Fastener and seam treatment and reinforcing.
- Localized rust-inhibitive priming.
- No more leaks.

This GateGourmet roof is a great example of a full systems approach to roof restoration--replace failed areas, prepare and reinforce fasteners and seams, prime as needed, and apply a Cool Roof coating.
