Night shift

Madsen Roof Co. Inc. performs nocturnal roof system maintenance

Madsen Roof Co. Inc., Sacramento, Calif., faced that challenge when it performed roof system repairs and coating installation on the headquarters building of the California Lottery Commission in Sacramento.

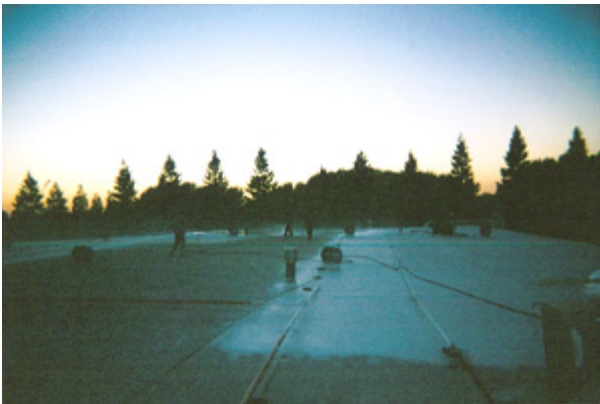
The crew of Madsen Roof Co. Inc., Sacramento, begins the "day's" work at sundown.

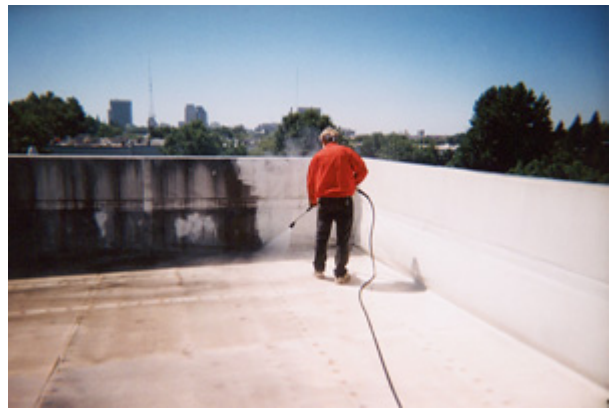
Power washing with hot water to remove algae from the existing PVC roof

Working under spotlights, often until dawn, required staging the work areas and relocating all the lighting equipment as work areas were completed. The crew power washed the single-ply membrane with water at 105 F (41 C) to remove all contaminants. Madsen Roof applied National Coatings PVC primer and a base coat of A600 quick-set adhesive. The crew broomed a layer of polyester into the quick-set adhesive and applied another topcoat of A600. Two more topcoats of A600 were applied to increase thickness.

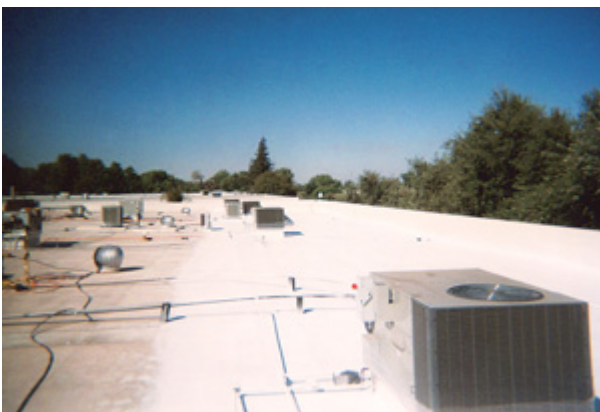
The new reinforced coating system in the process of being applied over the old PVC membrane

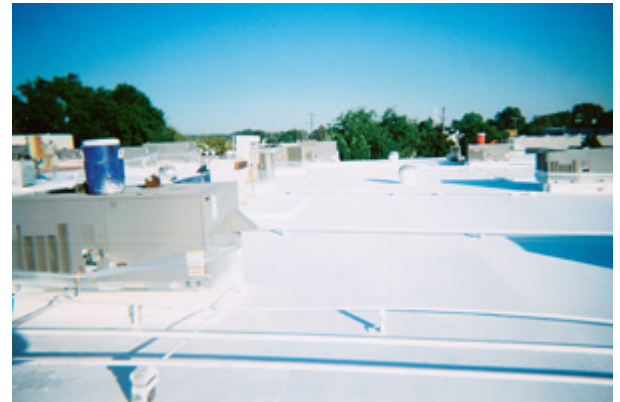
The topcoat process and HVAC protection

"HVAC units draw in significant outside air from the perimeter of the units," Madsen says. "The spray application of acrylic coatings would generate odor close to the HVAC units. When the coatings were installed at night, the units were turned off and covered in plastic then uncovered for day use. This was done repeatedly as each coating application was installed."
